# DENTAL FILLING MODIFICATION TO IMPROVE MECHANICAL LOADING TEST REPORT

<b>PROJECT TITLE</b>	Dentistry Elevated
<b>Project Leader</b>	JOSEPH FOLEY
<b>ORIGINATION DATE</b>	[YYYY-MM-DD]

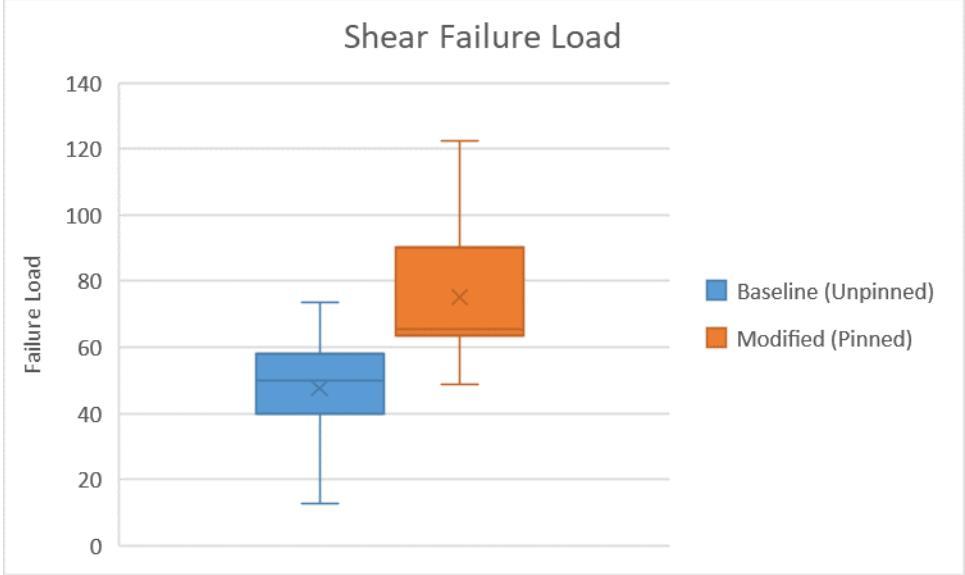
Figure 1. Failure Load Comparison

Group	Average (lbf)	Standard Deviation (lbf)	T Test – P Value
Basic	47.58	17.25	
Modified	75.13	19.60	
Difference	27.55	2.35	.0033

- 1) From table 3, the average failure load of the modified fillings is significantly greater than that of the base fillings. The standard deviation is slightly higher for the modified fillings, but not significantly different. It is important to note that the T-test has a value lower than .05 which means the modified fillings demonstrate statistical significance in comparison to the base fillings. This means the modified fillings are an overall improvement when compared to the base fillings.

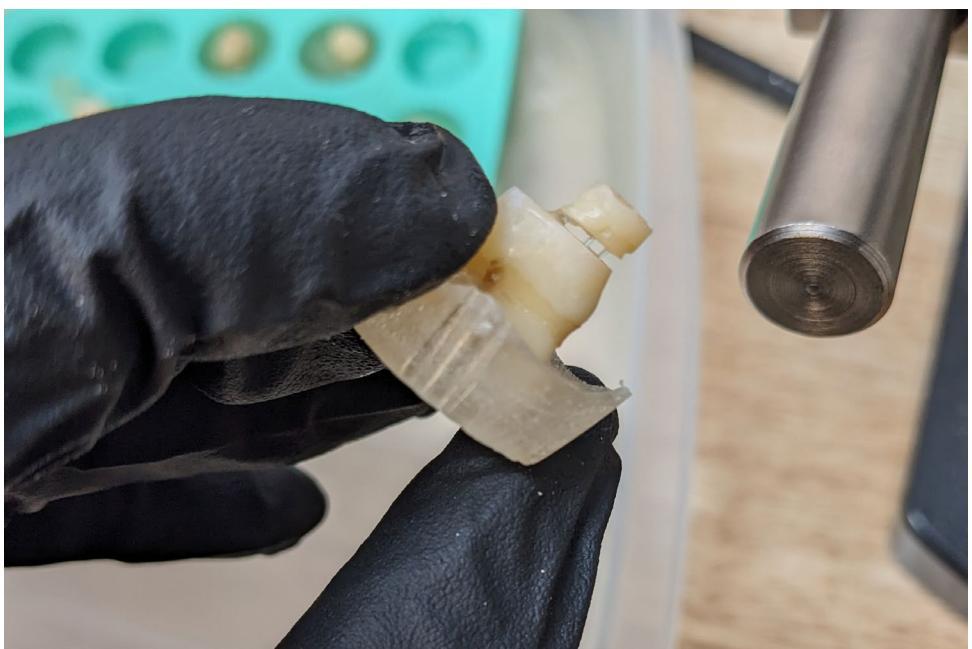
Figure 2. Failure mode 1 (slight separation)

- 4.4 Discussion of Results.
  - 1) For the base fillings, all failures were mode 2. However, for the modified fillings, samples 1, 2, 6, 10, and 11 demonstrated mode 1 failure. In mode 1 failure, at least one glass pin did not shear, and the filling simply separated from the tooth. All other samples in the modified fillings demonstrated failure seen in figure 4 where the pins would shear upon separation.

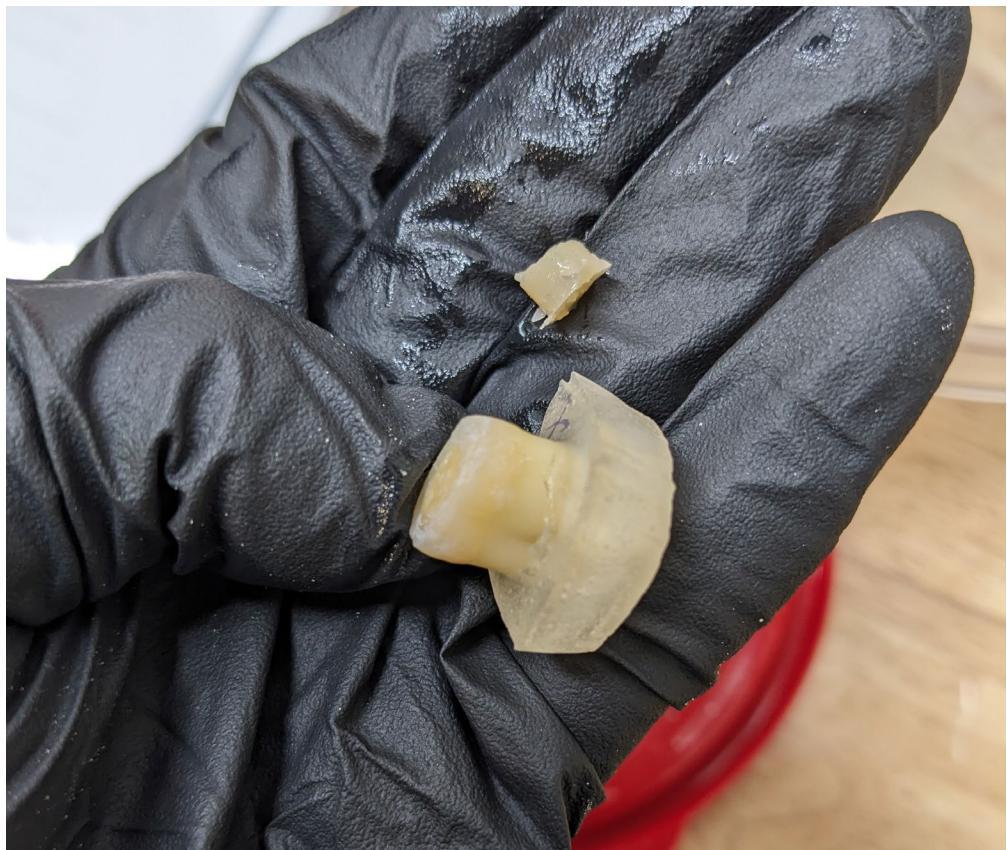
Figure 3. Failure mode 2 (clean breakage)

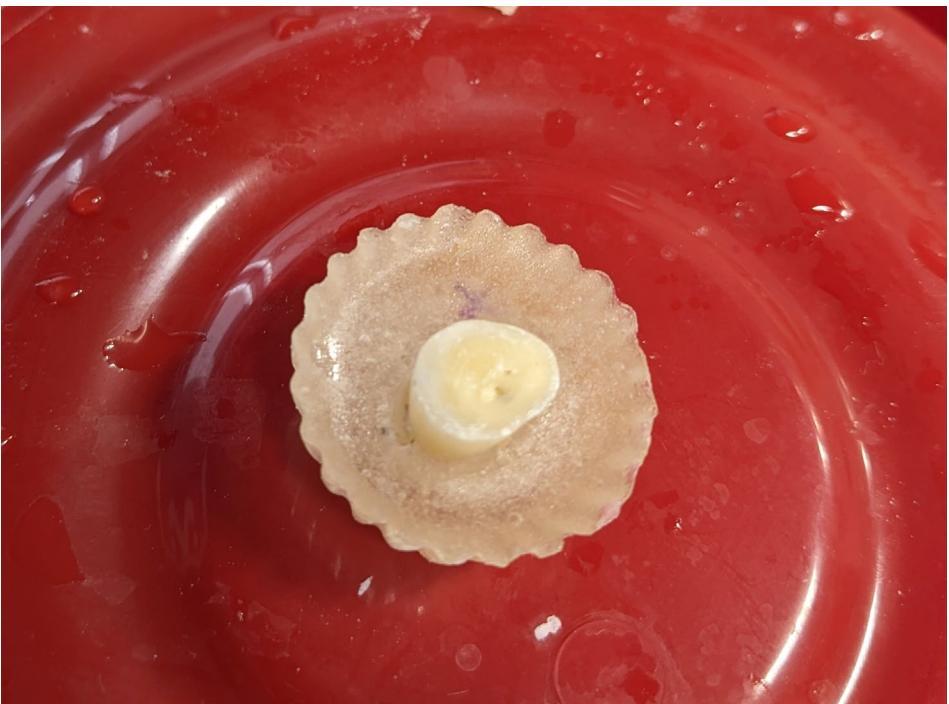
Figure 4. Group 1 sample 4, evident holes on bond line

Table 1. Basic filling results					
Sample #	Failure Load (lbf)	Displacement at Failure (mm)	Comments		
1	39.8	0.86	very quite, clean break		
2	58	1.12	clean pop		
3	53	0.89	clean pop, good sample		
4	22.8	0.65	Filling came off with no noise and barely any force, tooth has a hole/cavity by the bond		
5	70.8	1.59	explosive pop		
6	45.6	1.16	clean pop		
7	73.4	1.77	explosive pop		
8	12.6	0.3	filling came right off		
9	49.8	1.05	explosive pop		
10	52	1.08	clean pop, good sample		
11	45.6	1.19	clean pop, good sample

- 2) In testing of the base fillings there are two outliers in the data, one is 12.6 lbf and the other is 22.8 lbf. These values have not been omitted from the data. However, if they were, the group one average and standard deviation go to 54.22 lbf and 10.75 lbf, respectively. This would also move the T-test value to .014 which is still less than .05 and shows statistical significance.

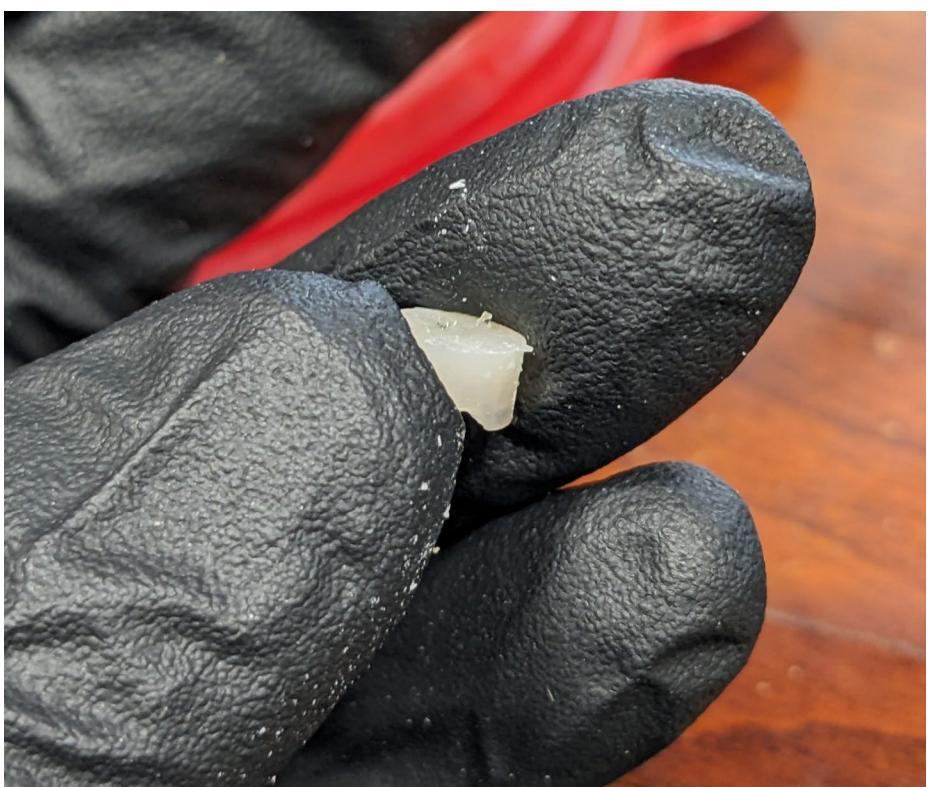
Figure 5. Pins shearing in group 2 samples when there was a clean break
